DELAWARE RIVER BASIN
MUSCONETCONG RIVER,
MORRIS & SUSSEX COUNTIES
NEW JERSEY

LAKE WATERLOO DAM

NJ 00276

6 PHASE 1 INSPECTION REPORT
NATIONAL DAM SAFETY PROGRAM

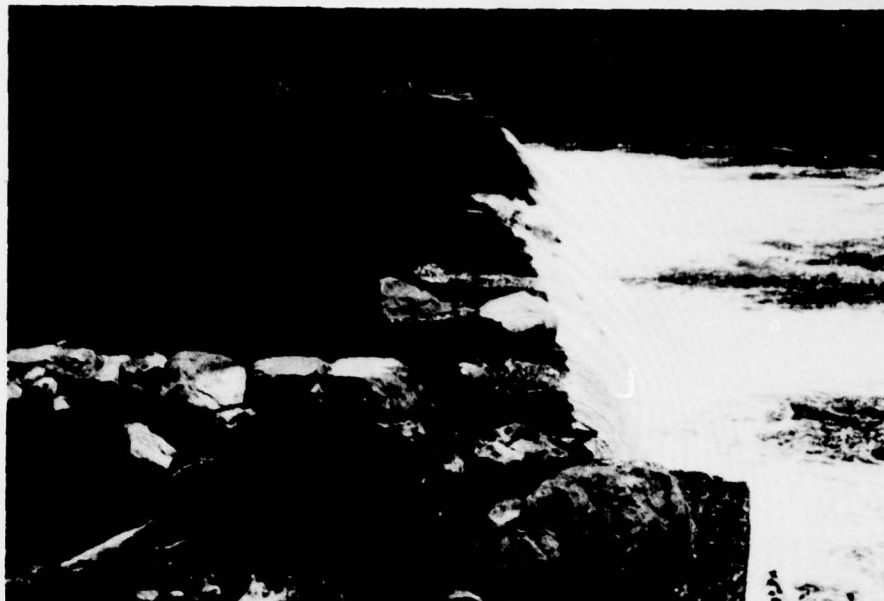
The crest and downstream face of the spillway are in generally adequate condition along their southern portions but are deteriorated near their north ends. The elevation of the crest is slightly higher near its north end so that spillway discharge does not overtop the north end during low flow periods. The timbers comprising the downstream face are

severely rotted near the north end. The stone masonry training walls at the north and south ends of the spillway are in fair condition.

PHOTO 1
SPILLWAY

In addition, it is recommended that a professional engineer experienced in the design and construction of dams be engaged in the near future to investigate the repairs made at the breach locations and to determine their adequacy and prepare a detailed design for embankment improvements, including any necessary filling, regrading and riprap, and the embankment should be renovated accordingly. This remedial work should include a complete inspection and renovation of the spillway.

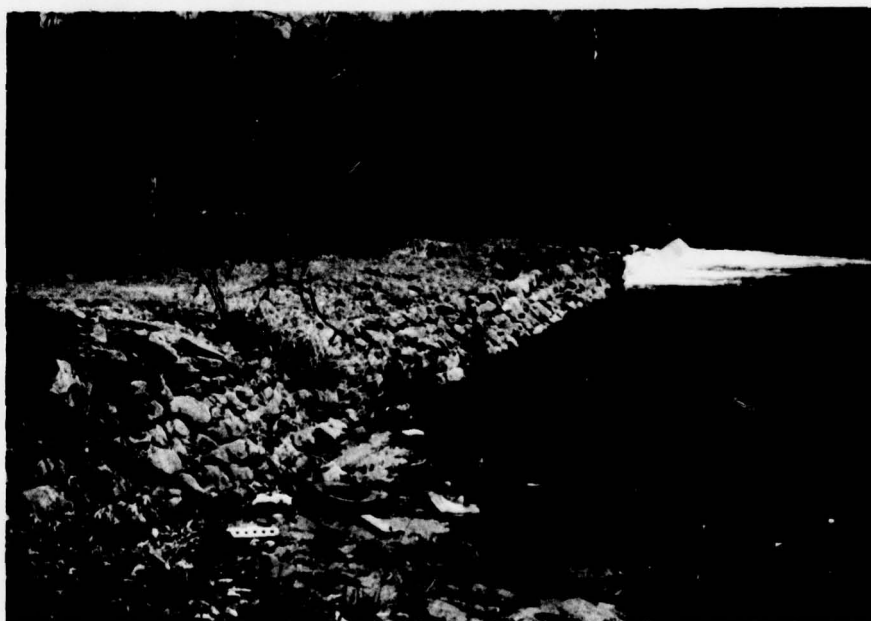
PHOTO 4

DOWNSTREAM FACE OF DAM

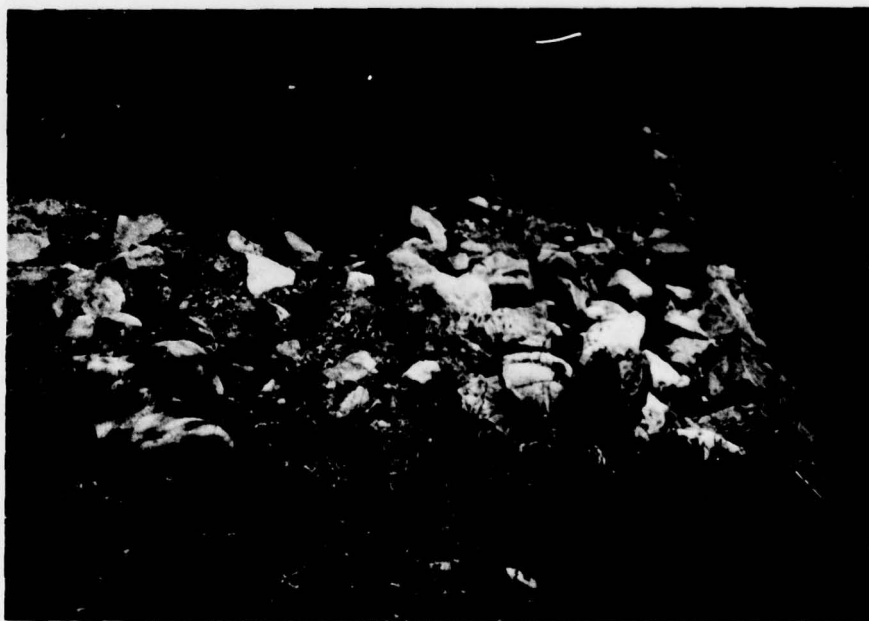
PHOTO 6

REPAIRED BREACH - SOUTH SECTION OF DAM

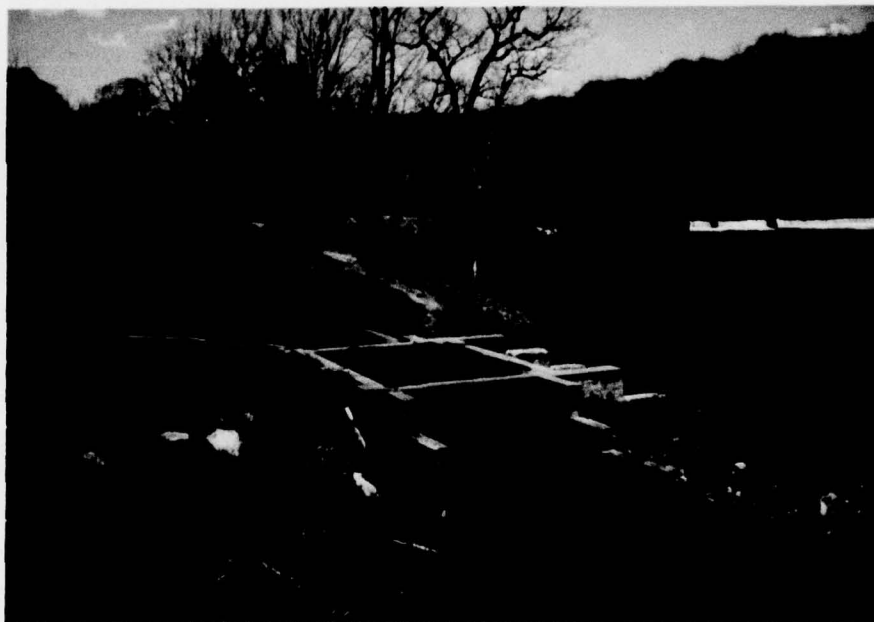
PHOTO 8

Most of the concrete surfaces of the outlet works are generally in satisfactory condition. Some spalling and exposed aggregate was noted on the inside of the chamber and significant spalling was noted on the downstream wingwalls. The stoplogs appeared to be in generally adequate condition although they were submerged by overflow at the time of inspection.

OUTLET WORKS

- 1) Trees on the embankment should be removed.
- 2) The outlet works should be renovated by patching deteriorated concrete and coating with an epoxy sealant. Also the timber stoplogs should be thoroughly inspected and replaced if necessary.

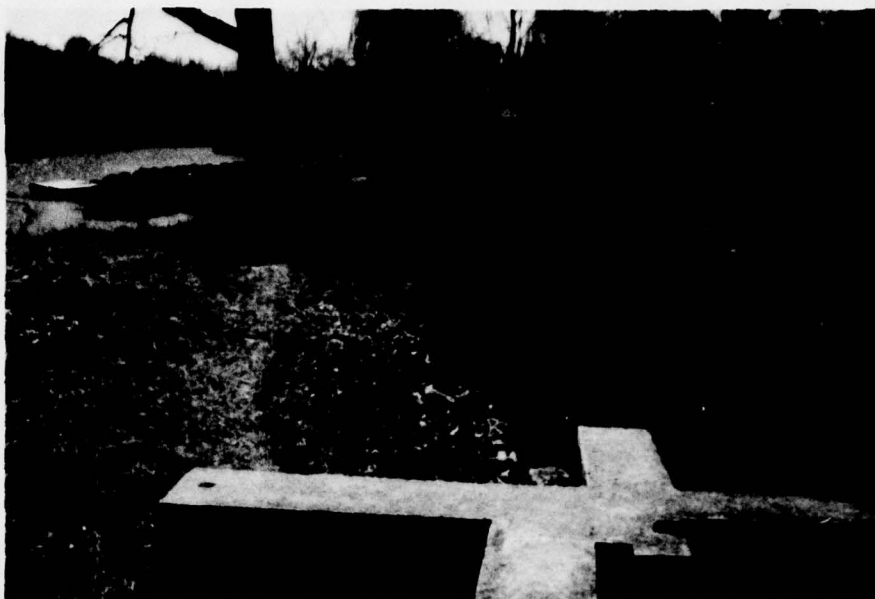
PHOTO 9

OUTLET WORKS DISCHARGE CHANNEL
